NATIONAL TRANSPORTATION SAFETY BOARD

MATERIALS LABORATORY FACTUAL REPORT

Report No. 06-088

Place : Boston Harbor, Massachusetts
Date : June 12, 2006
Vehicle : M/V Massachusetts
NTSB No. : DCA06FM016
Investigator : Brian Curtis OMS

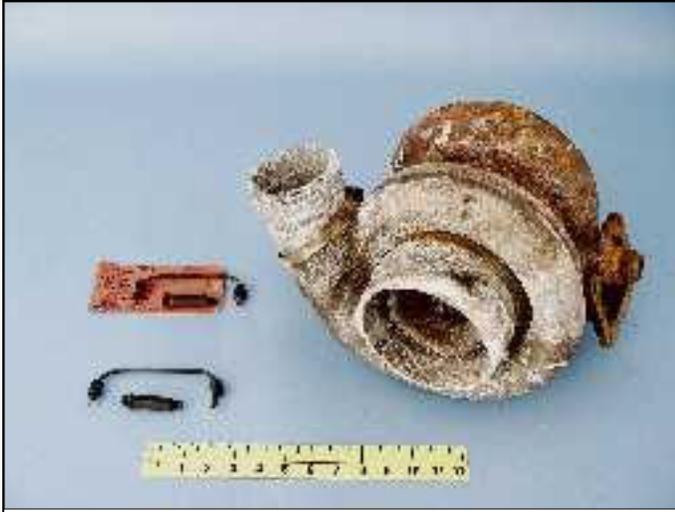
Image No.:0607A00234, Project No.: 2006070004

Figure 1. Overall of fuel lines and turbocharger. Exemplar at top left.

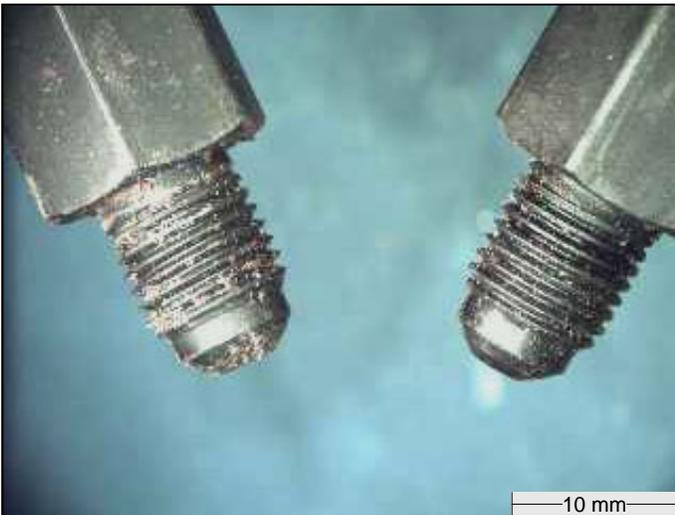
Image No.:0609A00322, Project No.: 2006070004

The fuel oil jumper line with surface fittings was submitted for examination. The jumper line was found disconnected from the nipple connector at the time of the on-scene investigation. An exemplar line from the same engine was also received. Reportedly, the engine had undergone maintenance just prior to the accident. The threads on the nut and nipple connector of the unconnected line showed no mechanical damage. The threads of the nipple connector and nut end had areas of oxidation and debris trapped within the threads. Oxidation and debris were also found inside the nipple connector. The connected line showed no evidence of oxidation or debris contamination. Figures 2 and 3 compare the nipple ends of the fuel lines.

Figure 2. Fuel line connectors, nipple ends. (Disconnected line on the left; connected exemplar line on the right)

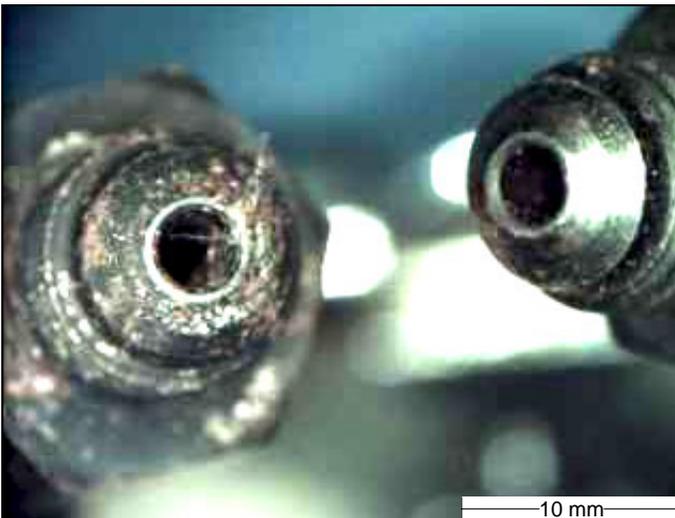
Image No.:0609A00323, Project No.: 2006070004

Figure 3. Close up of fuel line connectors- nipple ends. (Disconnected line on the left; connected exemplar line on the right)

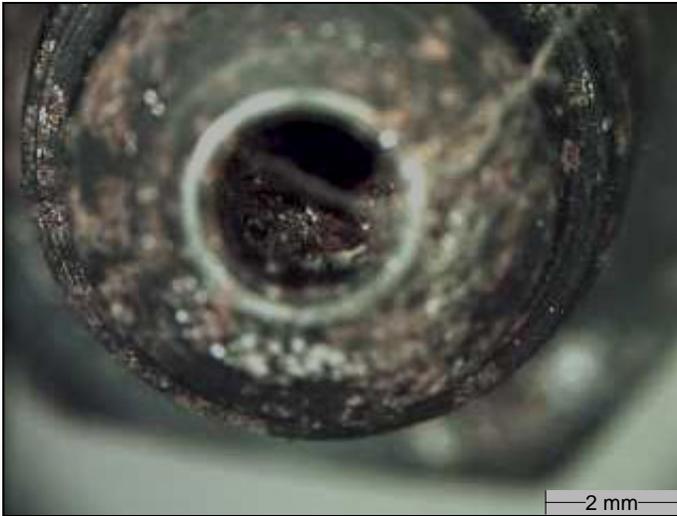
Image No.:0609A00325, Project No.: 2006070004

Figure 4. Close up of disconnected fuel line connector nipple showing the interior debris.

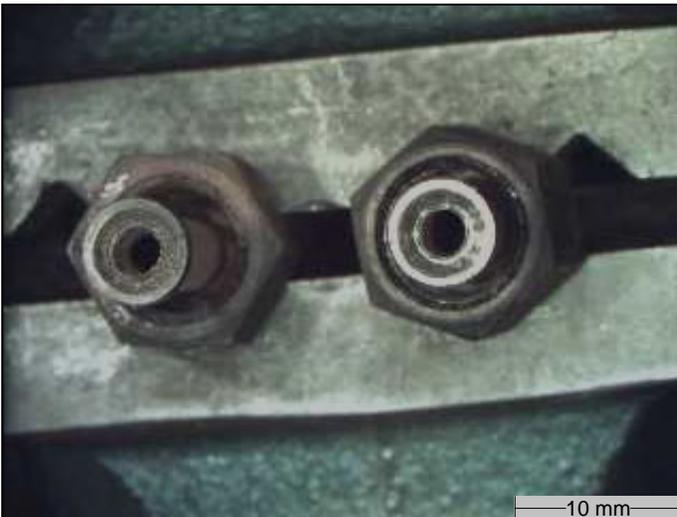
Image No.:0609A00327, Project No.: 2006070004

Figure 5. Close up of fuel line connectors- nut ends. (Unconnected line on the left; connected exemplar line on the right)

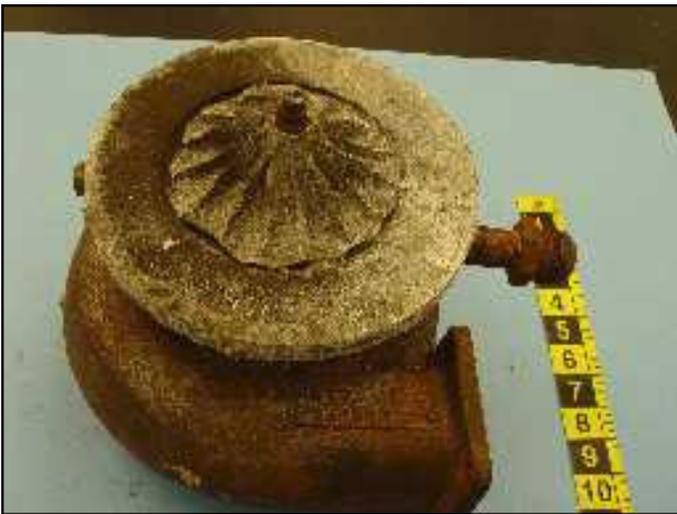
Image No.:0609A00335, Project No.: 2006070004

The aluminum exterior surface of the turbocharger was dull and powdery. The cover was removed from the intake side of the turbocharger for further examination. The aluminum impeller on the intake side of the turbocharger exhibited similar heat as the exterior cover. There were also areas of melting and pitting along the edges of the blades. There were no indications of mechanical damage on either the cover or the impeller. The EDS analysis on material removed from the surface of the cover and the impeller blades found the material to consist largely of aluminum and oxygen.

Figure 6. Turbocharger intake impeller

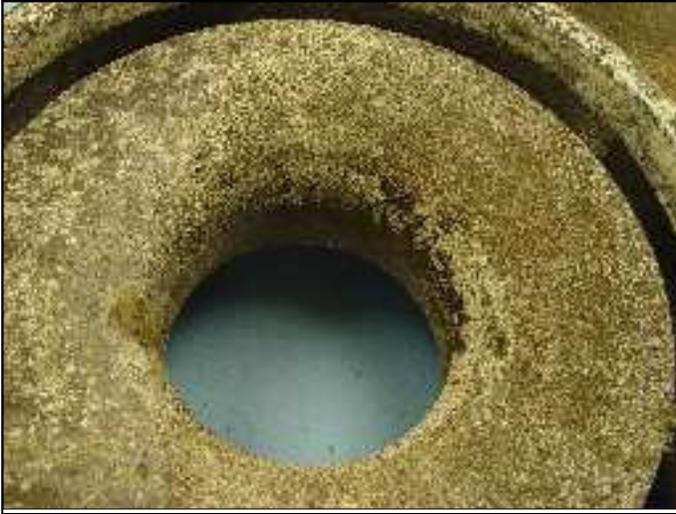
Image No.:0609A00339, Project No.: 2006070004

Figure 7. Turbocharger-Inside of intake cover
